Test and Analysis Correlation of Form Impact onto Space Shuttle Wing Leading Edge RCC Panel 8

Edwin L. Fasanella, US Army Research Laboratory, Vehicle Technology Directorate, Hampton, VA

Karen H. Lyle NASA Langley Research Center. Hampton, VA

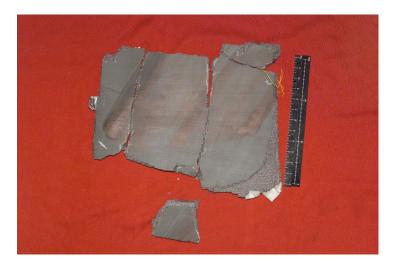
Figure 4. The major RCC fragments from the impact test.

The most obvious result from the test was the large 16-in x 16-in hole in panel 8 that is illustrated in Figures 2 - 3. Also, the RCC fragments from the hole that were created by the foam impact were collected and are illustrated in Figure 4. The ruler at the right side of the figure measures 12 inches in length.

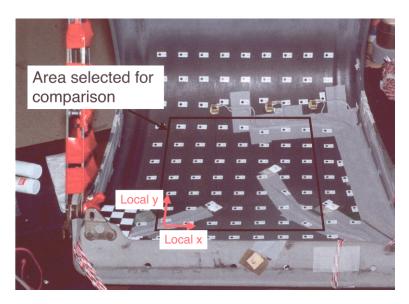
Figure 9. Photogrammetric targets on the back of Panel 8 in the SwRI test.

The displacements of targets on the backside of panel 8 were captured by high-speed video cameras. This photogrammetric data were analyzed in the region outlined by the square in Figure 9. Since the local axis system shown in Figure 9 did not align with the model axes, the photogrammetric data were processed to obtain a resultant displacement at each point for a given time. The resultant displacement is a scalar quantity independent of the coordinate frame. The experimental resultant panel displacements for the points at various times were then plotted as contour plots and compared with the LS-DYNA predicted resultant displacement contours. A typical comparison of test with analysis is shown in Figure 10 for a time of 1.8 ms after foam impact. The panel began to break up around 2.0 ms after foam impact.
